ALAMEDA MUNICIPAL GARAGE

core Historic Structure Report

15 July 2011

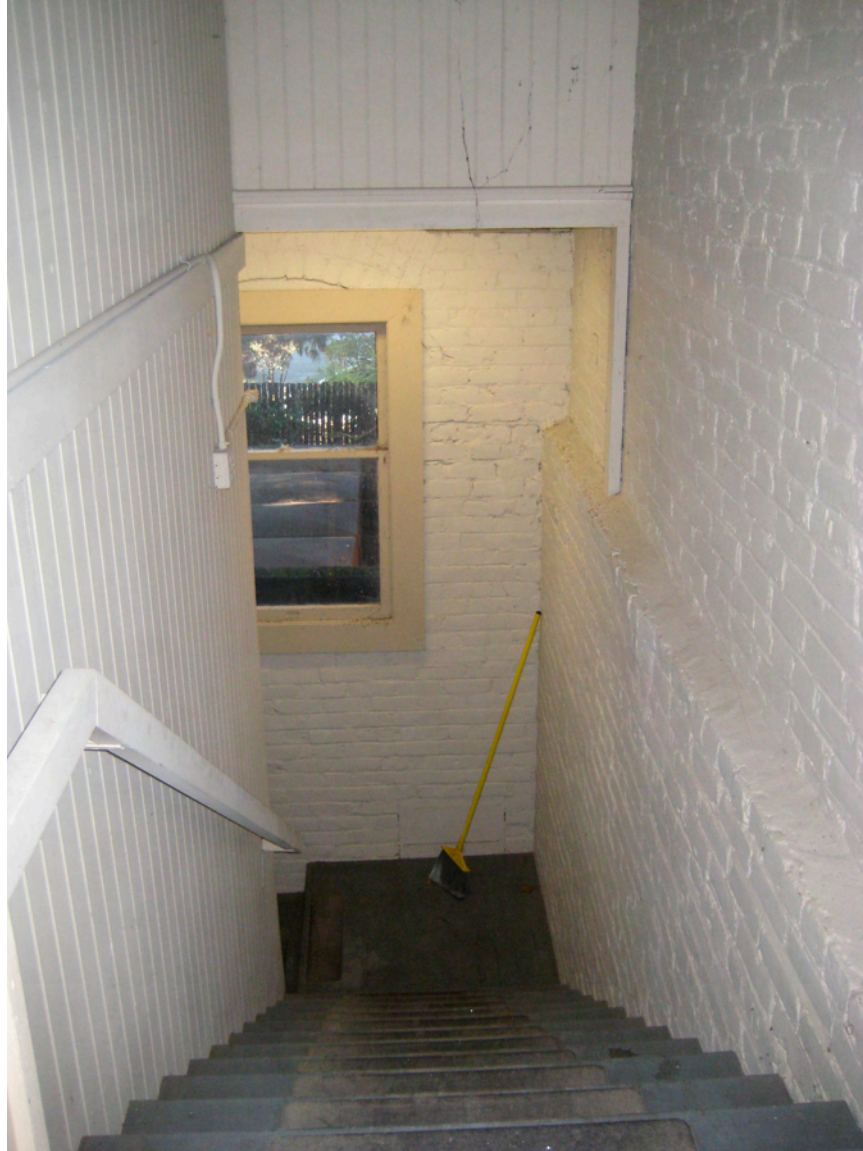
Figure 9. Enclosed stair leading from the south elevation to the second floor storage area. Based on remaining fabric, the area above the molding was likely originally open, with an entry door at the middle landing shown at the lower center of the photograph. (Photo by Garavaglia Architecture, Inc., 2011)

This space has been altered over time. There is evidence that the space was one room originally with a railing near the stair instead of the enclosed stair that appears today. There is evidence on the middle stair landing that a second door or a gate was installed. From here the stair continued up to the open office space. The continuous ceiling trim, remnants of beadboard finishes and markings on different finish elements all support this arrangement.

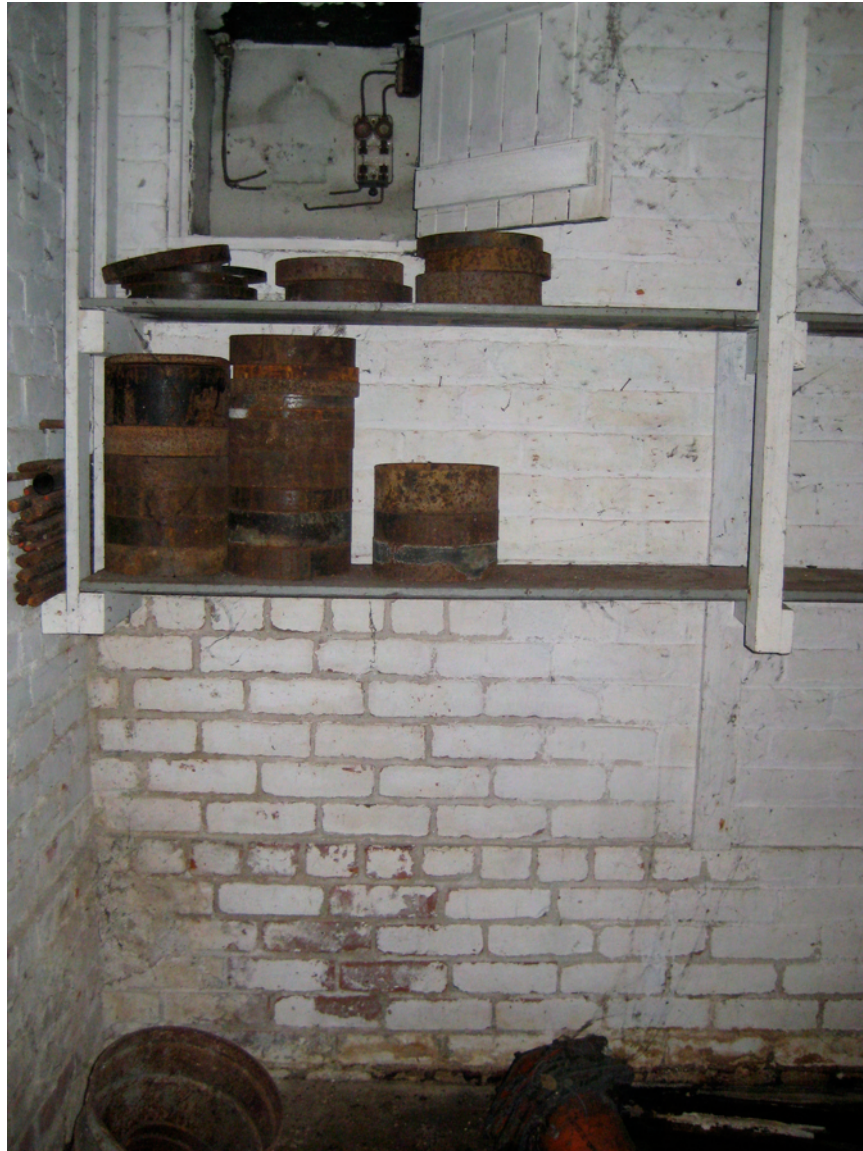
Figure 10. Storage room at the el-junction between the two-story and one-story building sections. Stenciled numbers, hook and shelving are extant as are the rusted canisters shown here. Standing water, a failing room and mortar loss are evident. (Photo by Garavaglia Architecture, Inc., 2011.)

On the exterior, a small storage room is built in the intersection of the large garage and the two-story portion of the building. This room has painted brick walls, a concrete floor and wood shelving along most walls. Stenciled numbers mark hooks along the top of the wall, and, at the time of the survey, rusting cans of an unknown material sat on the wet concrete floor.
